ARB FITTING INSTRUCTIONS

4740050 TAILGATE ASSIST SYSTEM RANGER PXIII 2018+ (WITH OEM TORSION BAR TAILGATE ASSIST)

FITTING KIT: 6177261

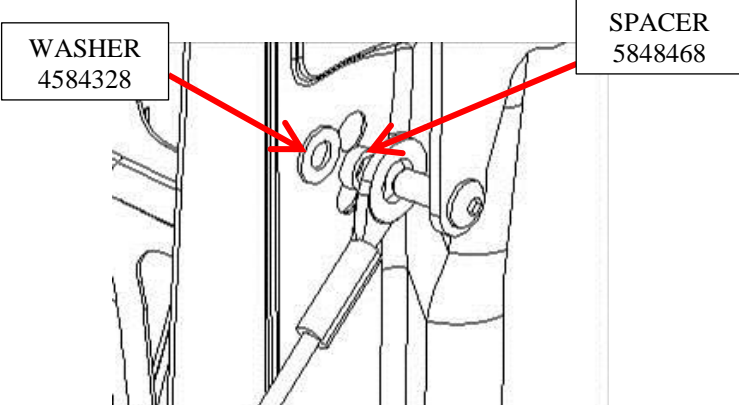
- 1.7) Drill marked hole out to 8.5mm. De-burr and paint or when complete.

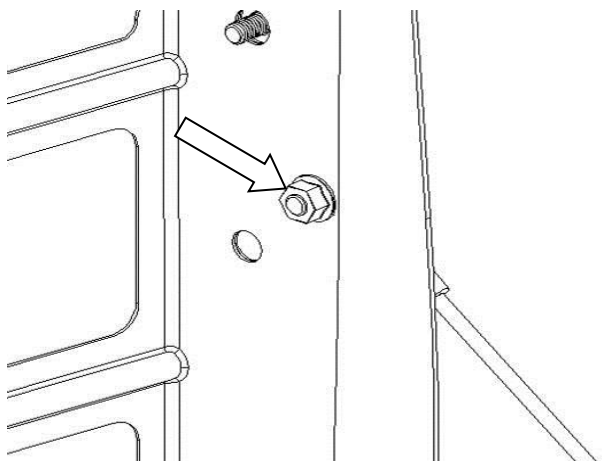
<p>1.9) Now place bracket assembly (3195061L) as prepared in step 1.5 to tub of vehicle making sure to fit the original latch plate between the mounting bracket and the vehicle tub. Loosely secure to the vehicle with original Torx head screws. DO NOT TIGHTEN.</p>

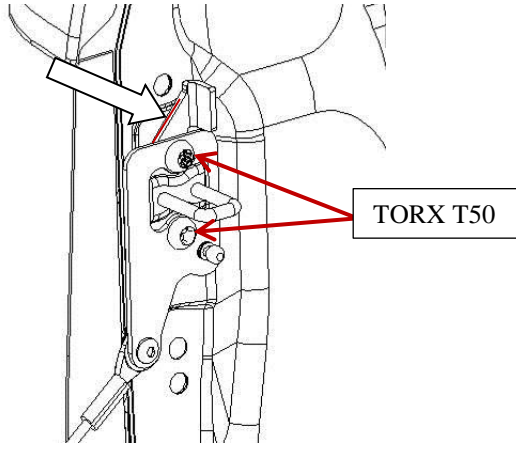
<p>1.10) From the inside of the tail light cavity fit an M8 flange nut (6151548) to the M8 cap screw (6151874).</p>

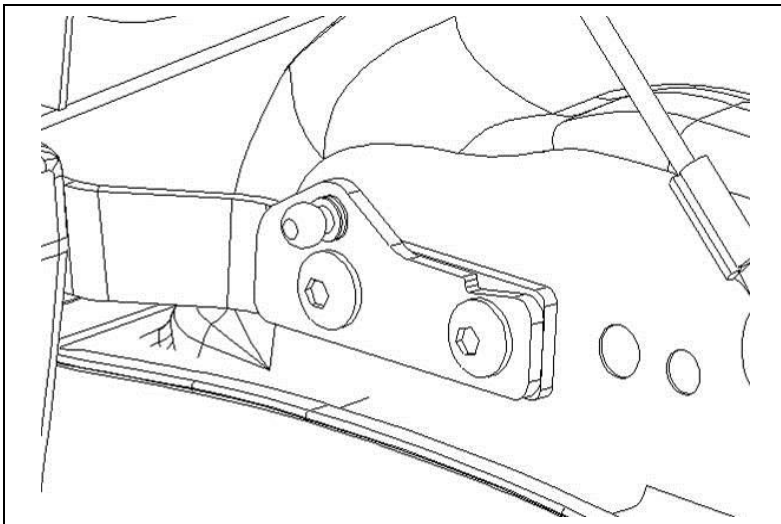
1.14) Using a T50 Torx bit remove and discard the two lower hinge bolts.

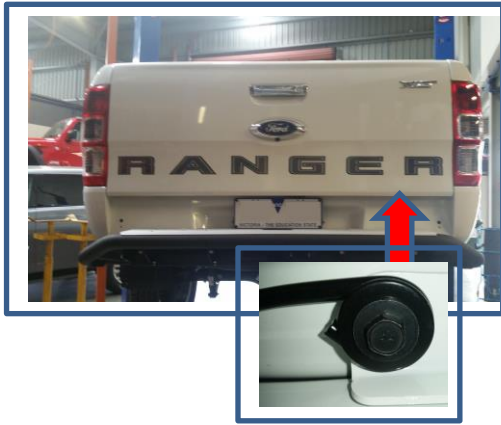
1.17) Fit the lower end of Dampener to tailgate bracket by lifting the tailgate up or by pulling the rod by hand to extend and attach to ball stud.
